PHASE I ENVIRONMENTAL SITE ASSESSMENT

Barrett Solar
Rains County, Texas

6/27/2023

Prepared for: BT Barrett Solar, LLC

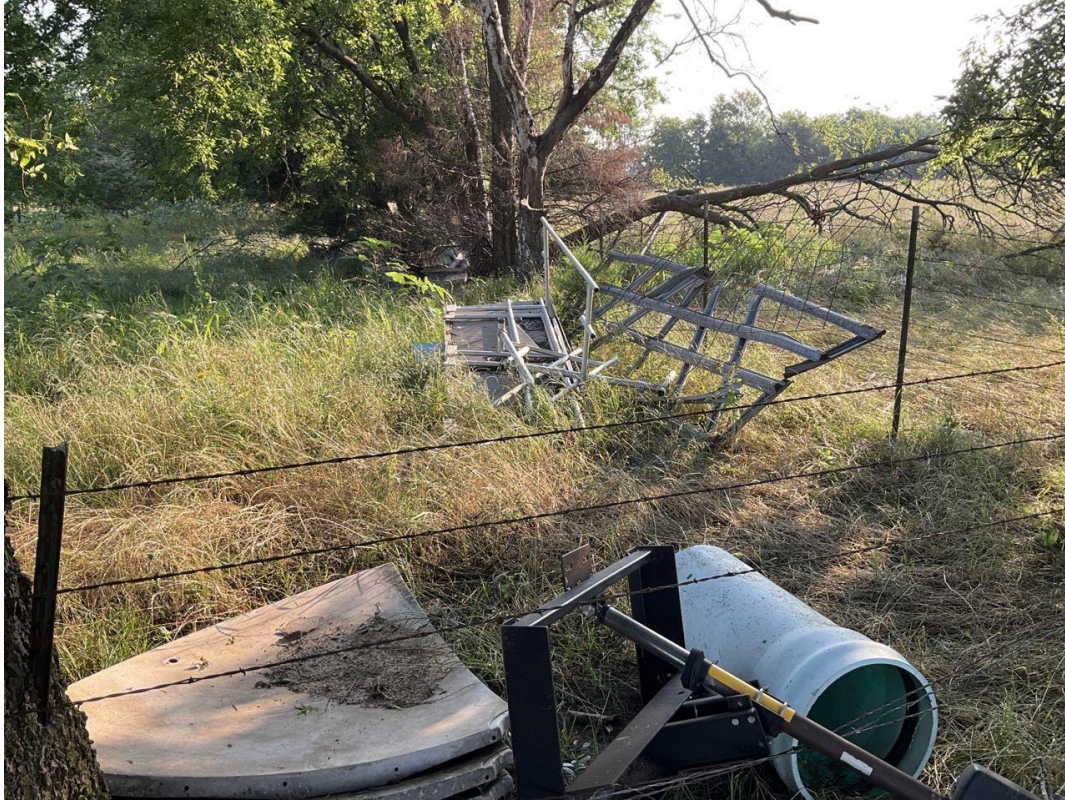
Photo 01: General metal and plastic debris.

- Minor dumping of barbed wire, concrete cinderblocks, plastic debris and scrap metal was observed on the Subject Property (**Appendix A, Figure 2**, and **Appendix B, Photos 01, 02, 07, 08, 09, and 11**). No hazardous materials were observed.

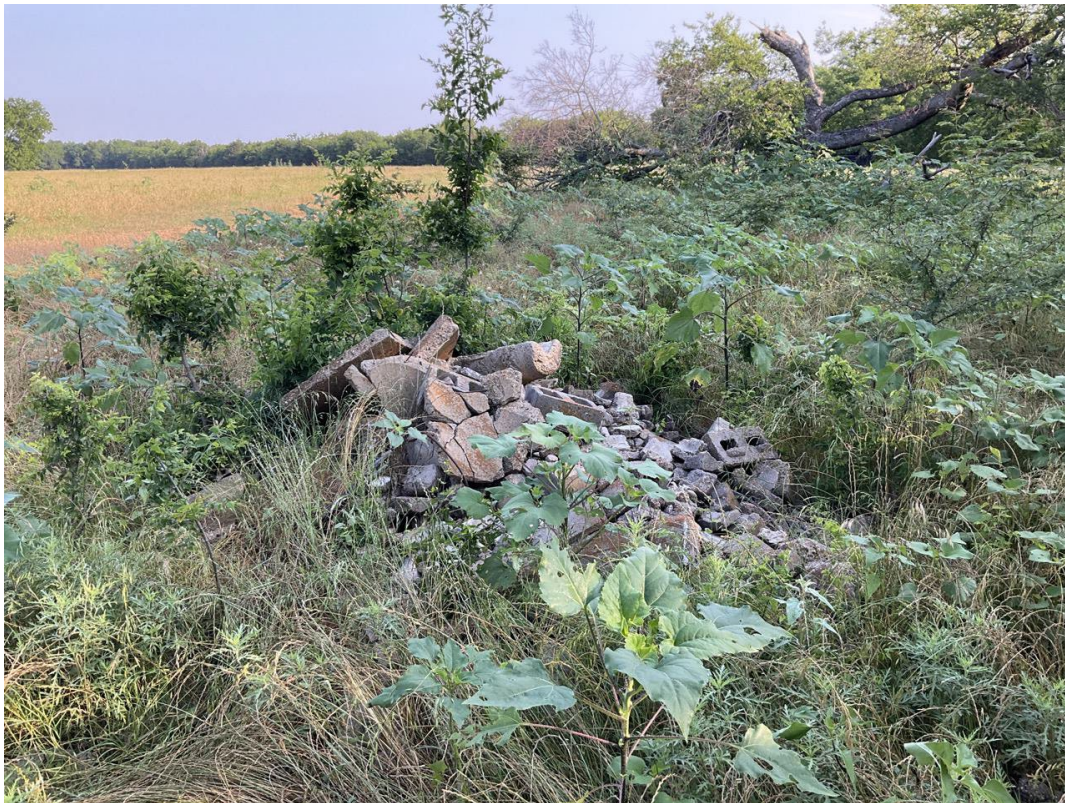
Photo 02: Concrete cinderblock pile.

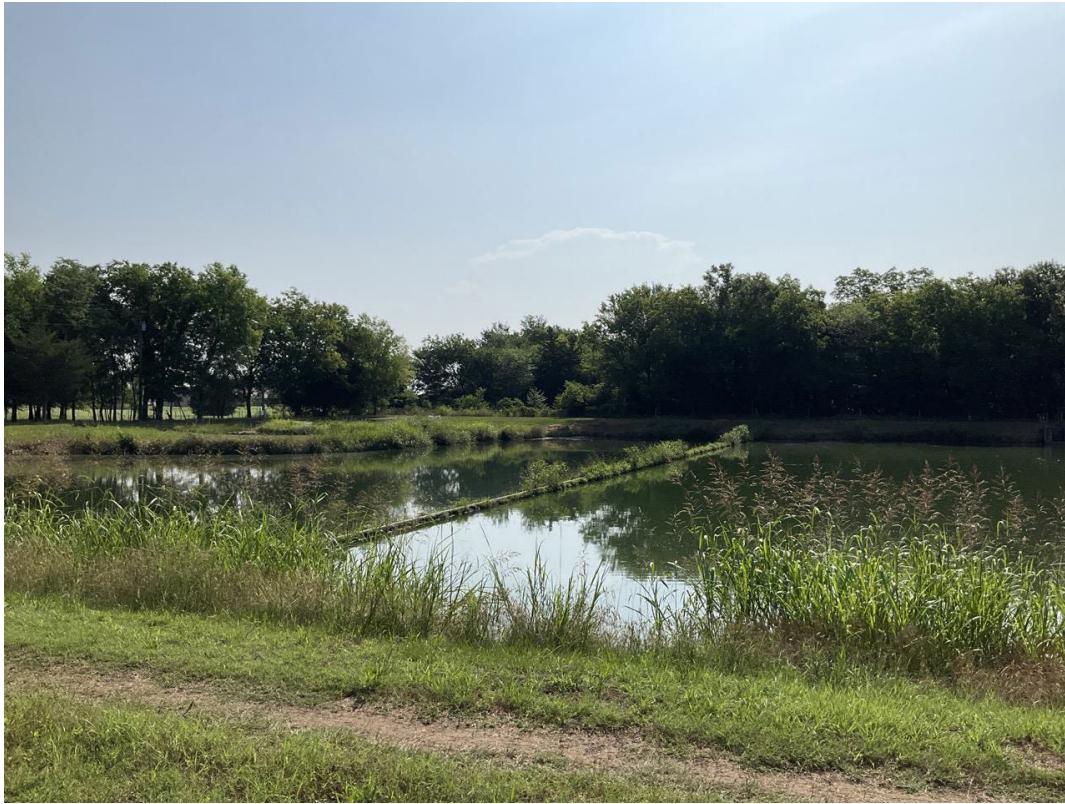
Photo 03: View of Map Key 1, western water treatment facility.

- A water treatment facility for the town of Point is located adjacent to the southeastern boundary of the Subject Property (**Appendix A, Figure 2, Appendix B, Photo 03, and Appendix D**). The database search returned Notices of Violation (NOVs) and Notices of Enforcement (NOEs) for this plant related to unauthorized discharges of sewage and failure to monitor effluent water quality. Any discharge from the plant flows into a ravine or creek east of the plant. This water flows south

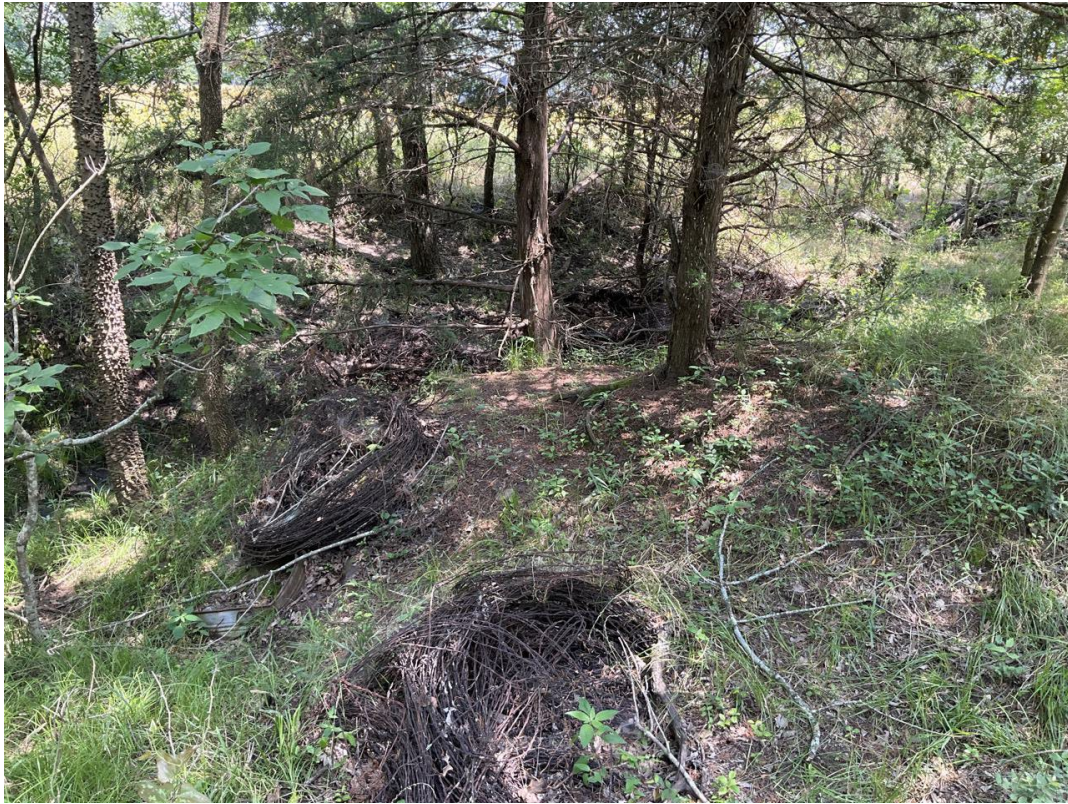
Photo 07: Scrap metal and barbed wire debris.

With the exception of minor residential and agricultural debris, including barbed wire and scrap metal (**Appendix A, Figure 2, and Appendix B, Photos 07, 08, 09, and 11**) no evidence of solid waste dumping, suspect fill material, or landfills was identified on the Subject Property during the site reconnaissance. There were no indications of hazardous materials associated with any debris.

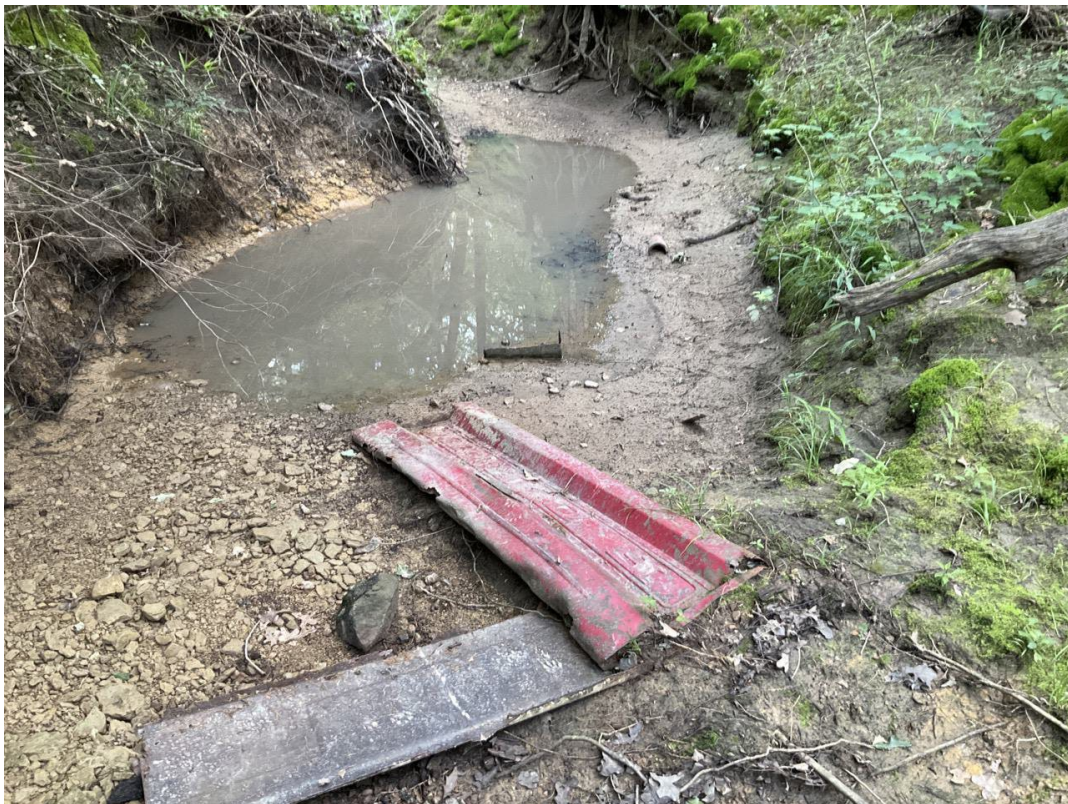
Photo 08: Metal debris in stream.

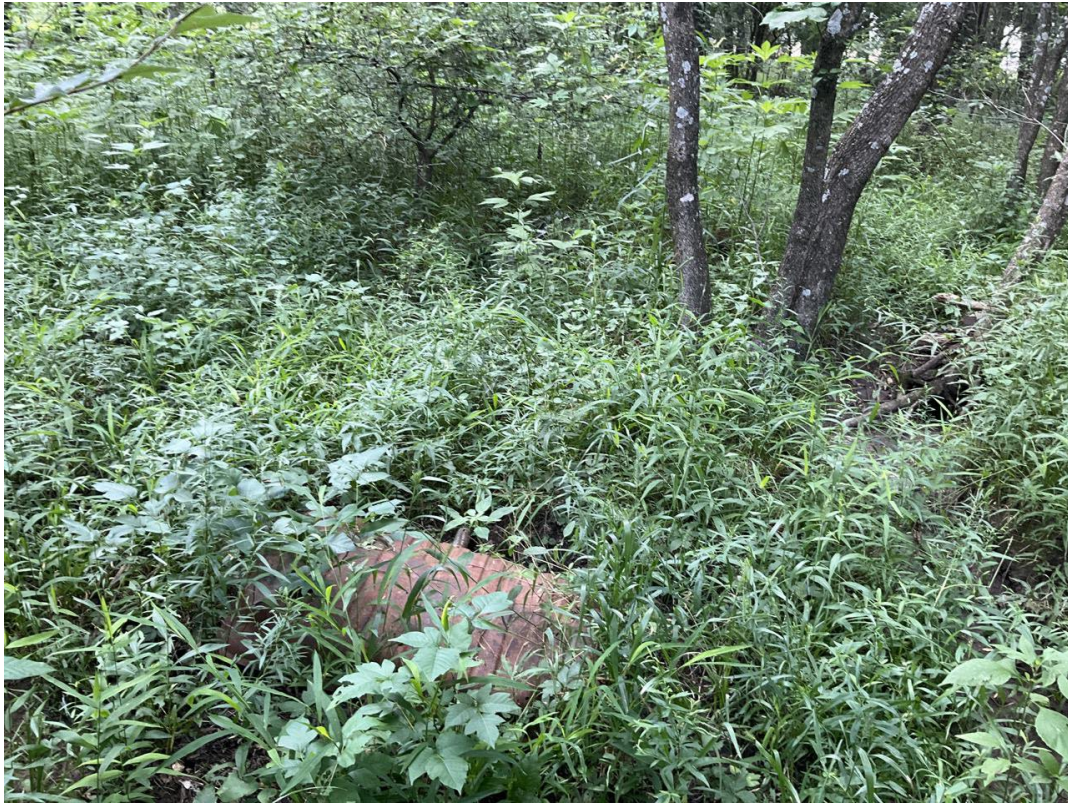
Photo 09: Metal debris dumping.

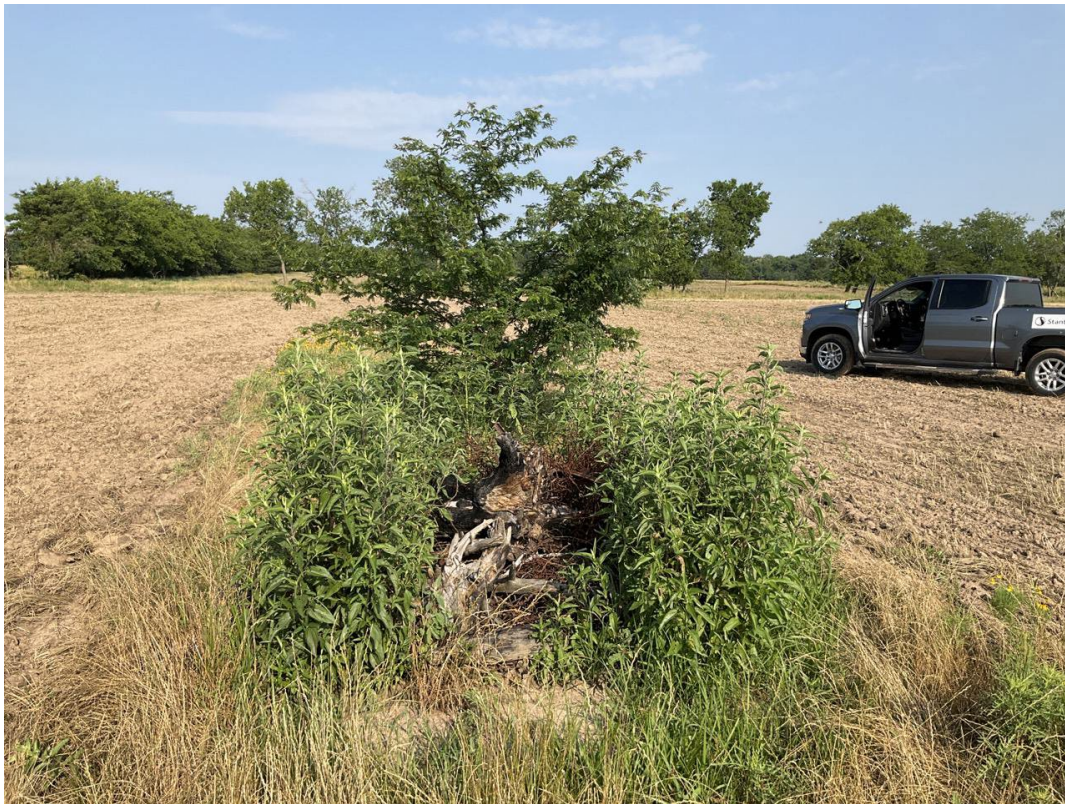
Photo 11: Dark spot-on aerial photographs, metal and wood debris.

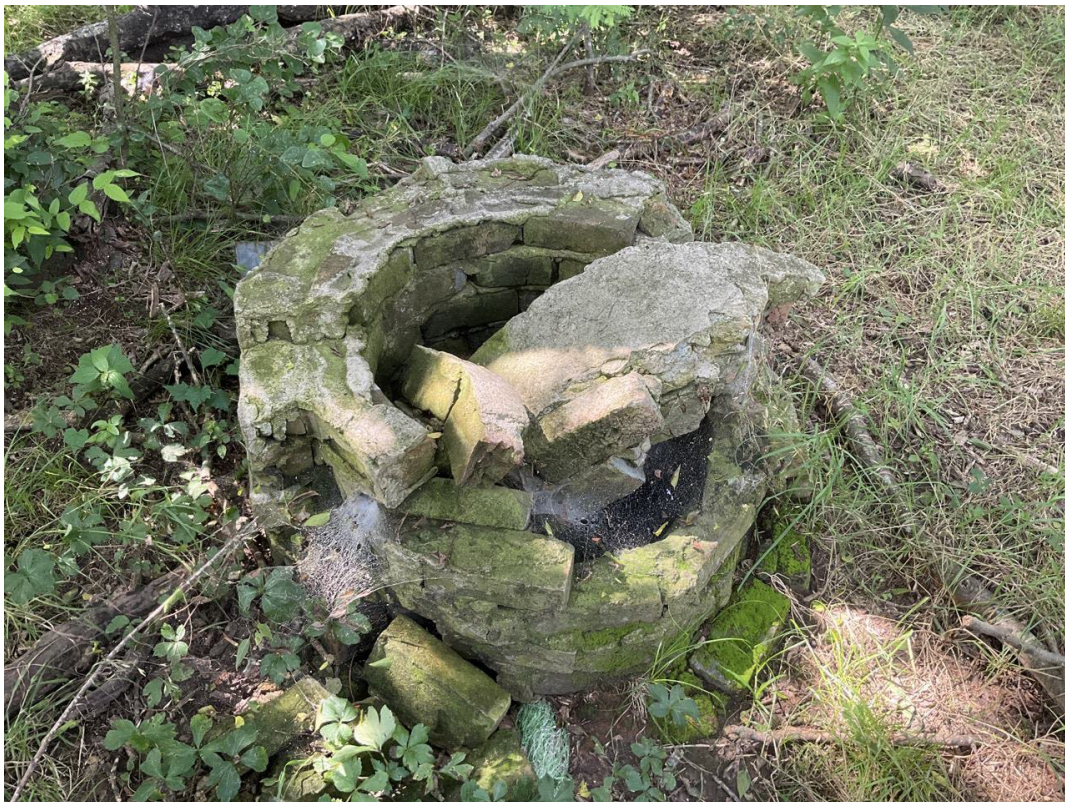
Photo 12: Representative photos of old wells or cisterns on the Subject Property, no longer in use.

Two old brick and mortar wells were observed on the southern portion of the Subject Property during the site reconnaissance (**Appendix A, Figure 2 and Appendix B, Photos 12**).

- Two old brick and mortar water wells or cisterns were observed on the southern portion of the Subject Property during the site reconnaissance (**Appendix A, Figure 2** and **Appendix B, Photo 12**). No hazardous materials concerns were observed to be associated with these structures.

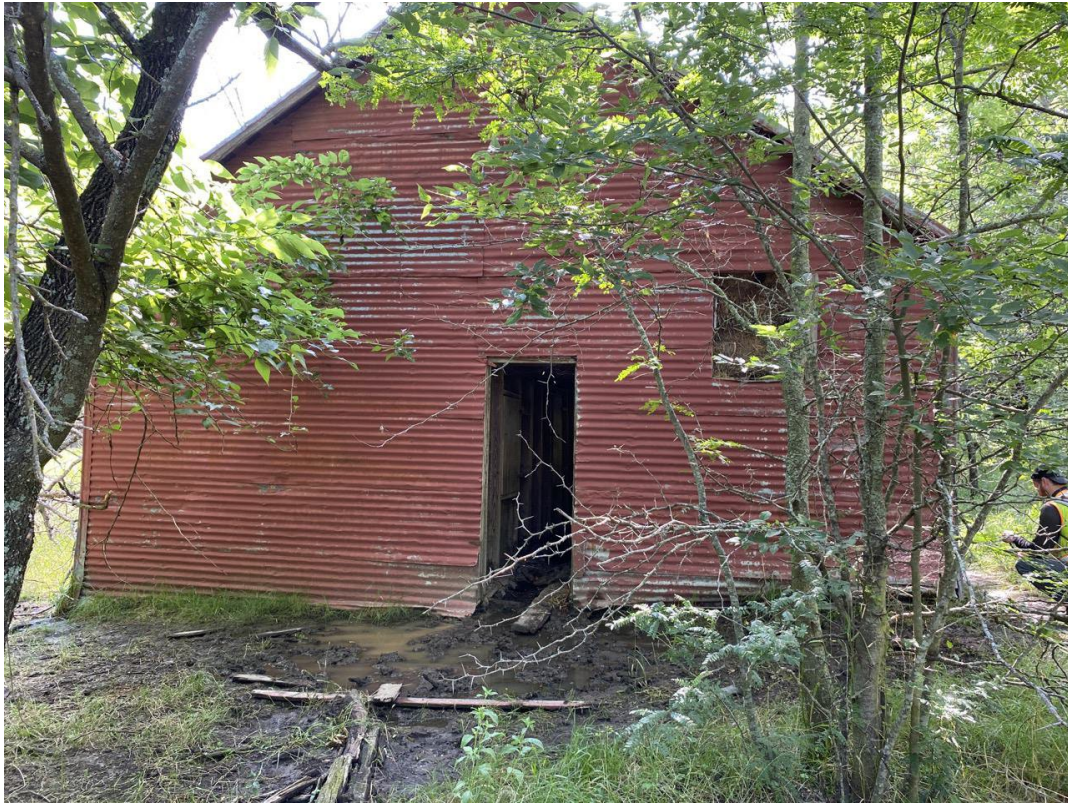
Photo 13: Old barn. No hazardous materials observed.
